**EMERGENCY SPILLWAY  
PERFORMANCE AT SITE 39,  
UPPER BLACK BEAR CREEK  
WATERSHED, OKLAHOMA**

**ARS-S-109  
March 1976**

By W. O. Ree<sup>1</sup>

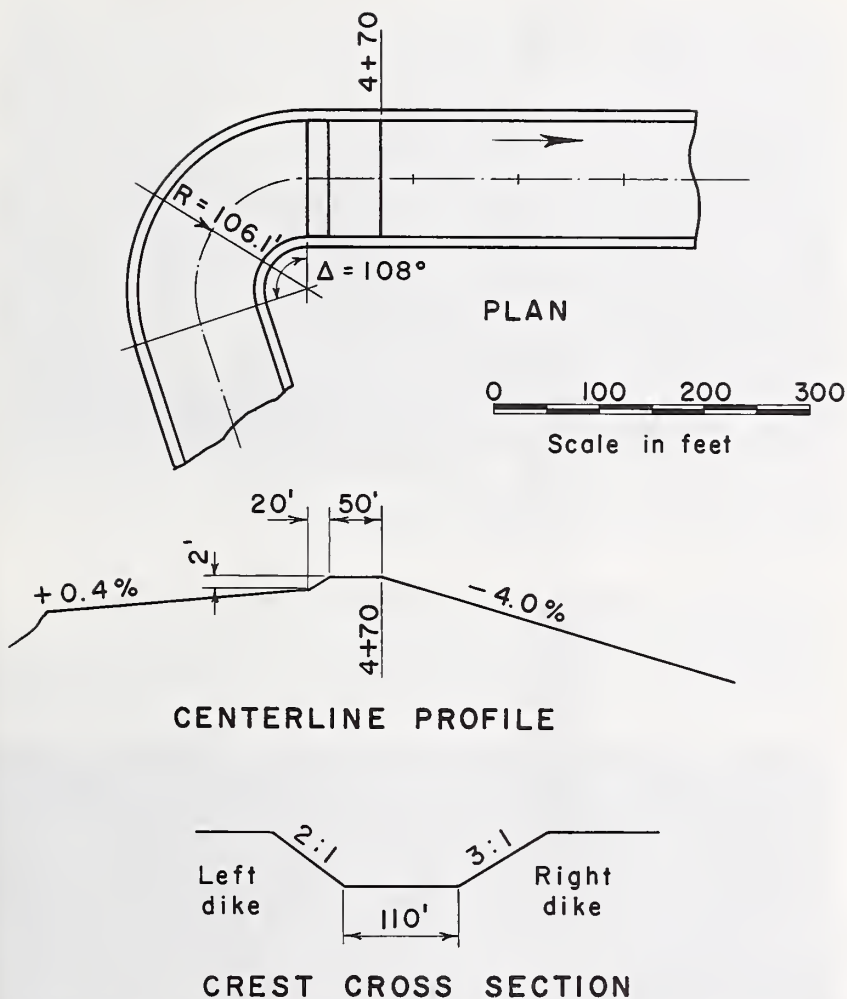
The emergency spillway for the reservoir is a grassed channel around the left end of the dam (facing downstream); its dimensions are given in figure 2. The spillway was constructed by excavating to cross section and subgrade in undisturbed soil, adding topsoil to a depth of 6 inches, and planting bermudagrass. Information on the soil in the spillway subgrade was obtained from the Soil Conservation Service and includes soil class — CL (unified classification); liquid limit — 42; plasticity index — 22; soluble salt — less than 0.5 percent; dispersion index — trace; and grain size distribution — 100 % < No. 10 sieve (2.0 mm), 82 % < No. 200 sieve (0.074 mm), 73 % < 0.05 mm, 50 % < 0.02 mm, 38 % < 0.005 mm, and 33 % < 0.002 mm.

FIGURE 2.—Dimensions of emergency spillway for floodwater-retarding dam.
